RECREATIONAL PATH INTERSECTION SAFETY

CROSS ALERT SYSTEMS, INC.

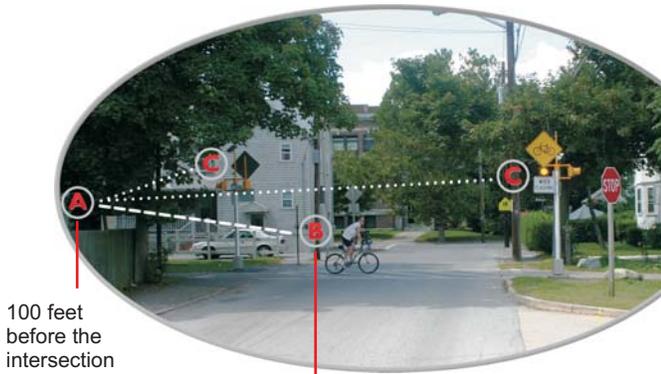
Cross Alert 2-Pole Intersection

100 feet before the intersection

Path user is detected by the Cross Alert System motion detector at point A.

Motion sensor immediately triggers flashing lights on Cross Alert poles at points C.

To provide the most cost effective safety solution for mid-block crossings, we designed our motion activated system to be solar powered, utilizing radio signals for communications between poles.

The radio signal can reach 500 feet from the intersection, which makes it possible to install an advance warning pole that can sit 500 feet in front of the intersection and flash when path activity is detected at the intersection.

crossing. This is accomplished with a stop sign and a flashing red light that is activated when the pole detects path activity.

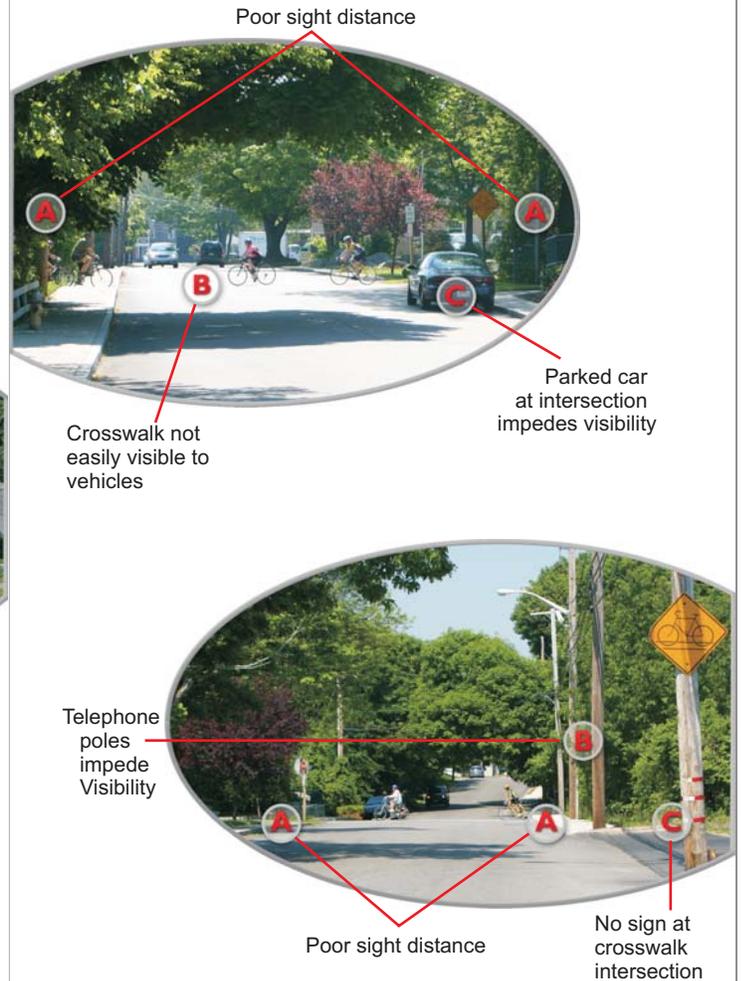
Poor Visibility Intersections

Poor sight distance

Crosswalk not easily visible to vehicles

Parked car at intersection impedes visibility

Telephone poles impede Visibility

No sign at crosswalk intersection
