RECREATIONAL PATH INTERSECTION SAFETY

CROSS ALERT SYSTEMS, INC.

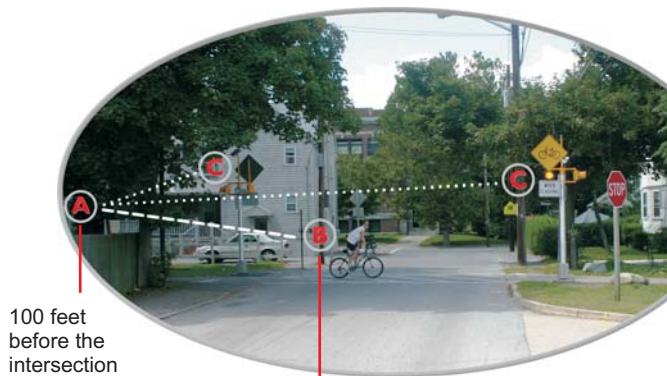
Cross Alert 2-Pole Intersection

Path user is detected by the Cross Alert System motion detector at point **A**.

Motion sensor immediately triggers flashing lights on Cross Alert poles at points **C**.
